Improved Guardrail Terminal

Development of a BEST Terminal to Comply with NCHRP 350 Requirements

**December 1998
Final Report**

NCHRP Report 350 Compliance Testing of the BEST System

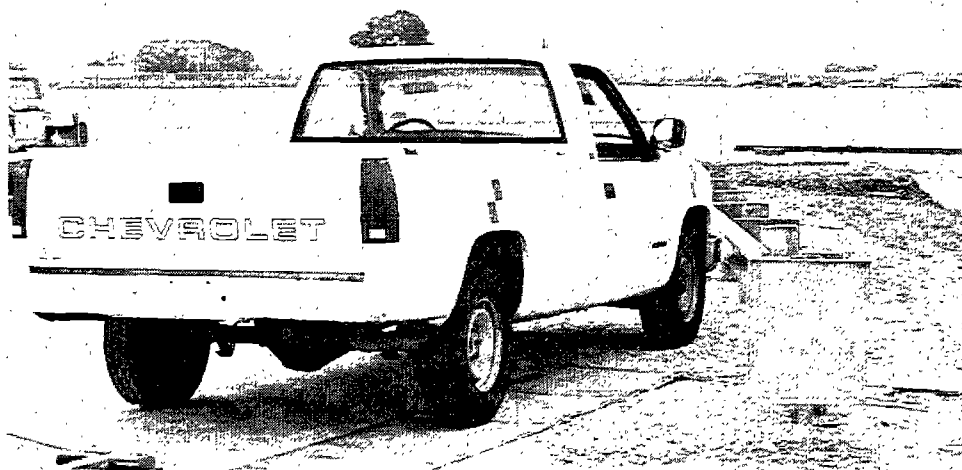
Figure 16. Impact Location, Test BEST-3.

The changes mentioned in the previous section were incorporated into the system for Test BEST-3, which was performed as a rerun of Test BEST-2. The 1992 Chevrolet $\frac{3}{4}$ ton pickup impacted the system 140 mm (5½ in.) upstream of post No. 3 at 102.7 km/h (63.8 mph) and 20.9 degrees. The impact location is shown in Figure 16. A summary of the test results is shown in Figure 17 and additional sequential photos are shown in Figure 18.

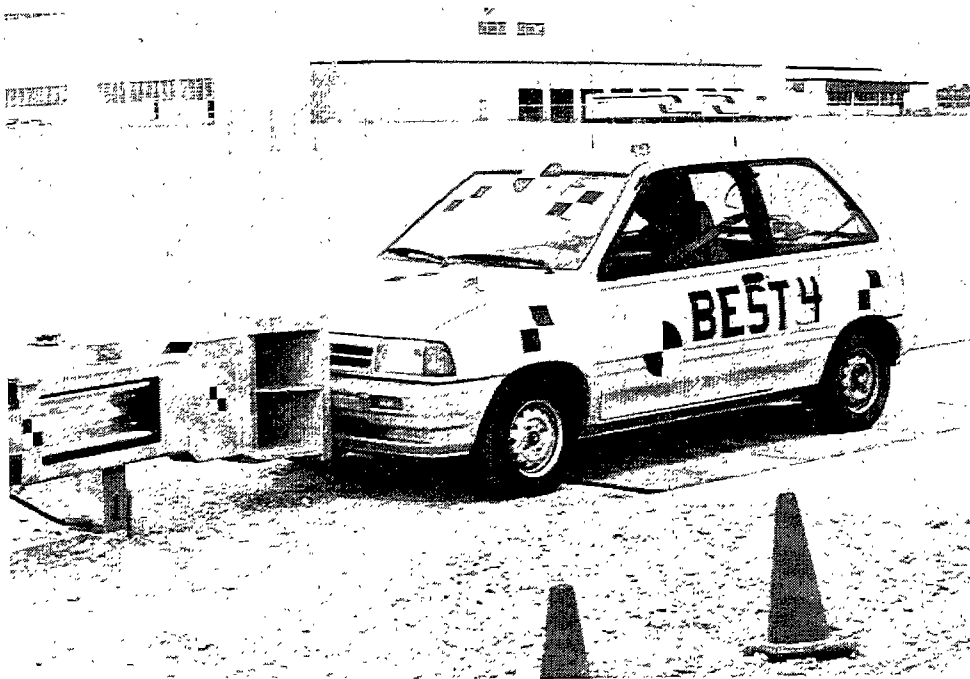
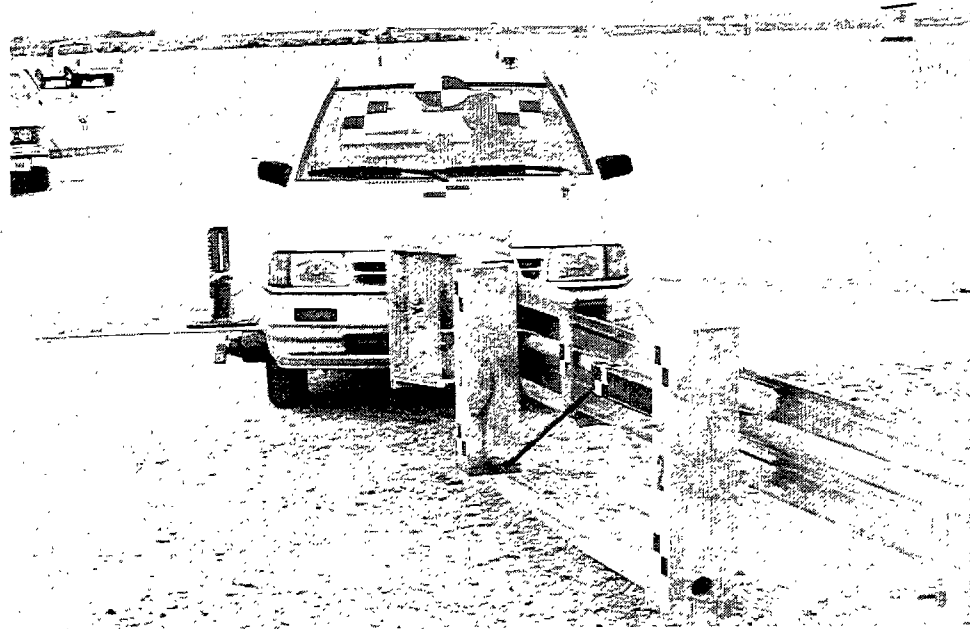
Figure 22. Impact Location, Test BEST-4.

This test consisted of a 1991 Ford Festiva impacting the end of the terminal at 101.7 km/h (63.2 mph) and 13.6 degrees. The impact configuration is shown in Figure 22. A summary of the test results is shown in Figure 23 and additional sequential photos are shown in Figure 24.

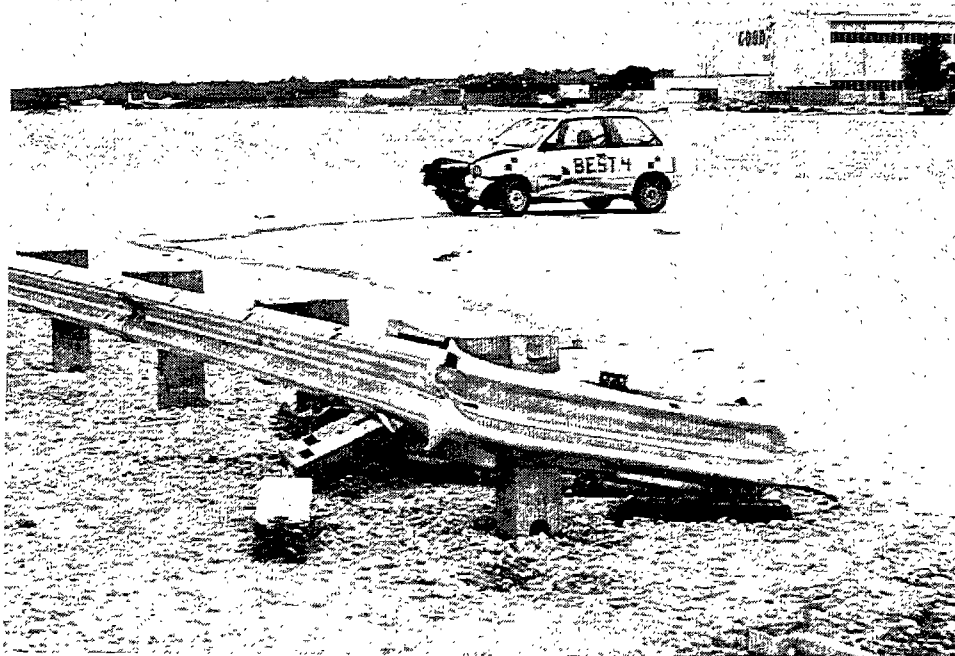
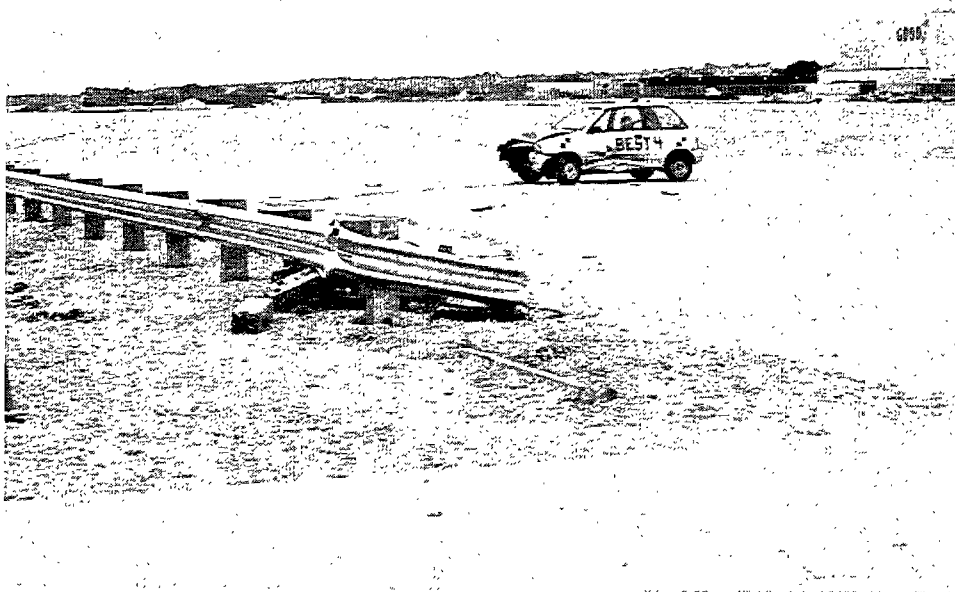
Figure 25. Vehicle Trajectory, Test BEST-4.

Upon contact with the terminal, the vehicle interlocked with the impact head and began to push it down the rail. At approximately 12 ms after impact the first post began to break as a result of contact with the post breaker. At 28 ms after impact, the end of the chute contacted the cable anchor box after which it released immediately. By 68 ms the end of the chute had reached post No. 2, and by 74 ms a buckle in the rail was visible in the chute from the overhead view. This buckling continued and the impact head and W-beam was rotated around and out of the vehicle path. As the vehicle passed by the buckled rail, the drivers side door contacted a portion of the rail, causing it to deform slightly. The vehicle came to rest with the front-left tire 24.5 m (80 ft - 3 in.) downstream of impact and 11.1 m (36 ft - 4 in.) behind the rail as shown in Figures 23 and 25.

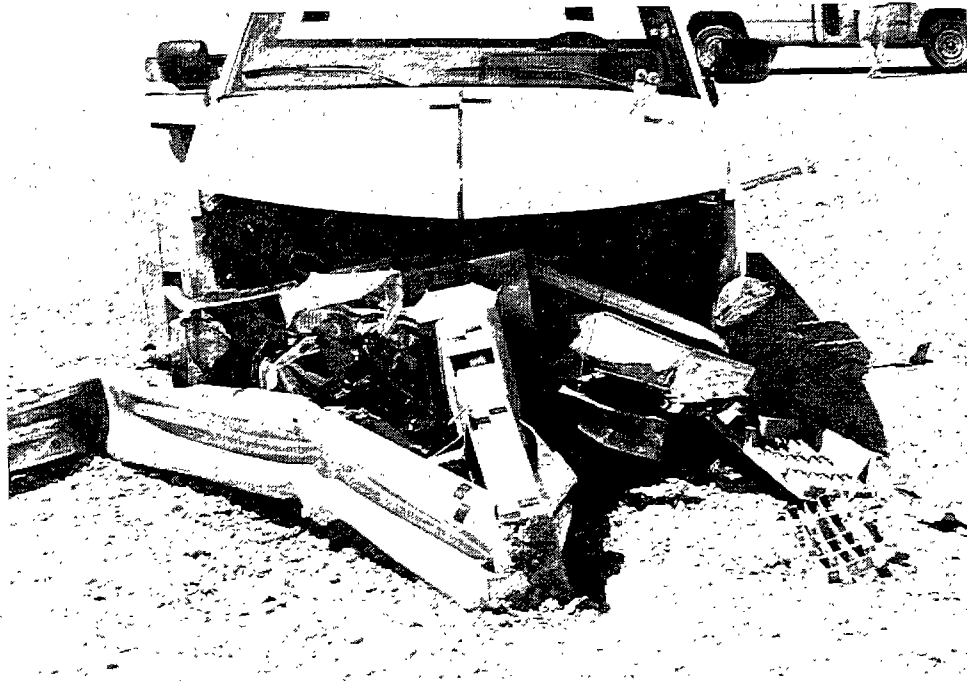
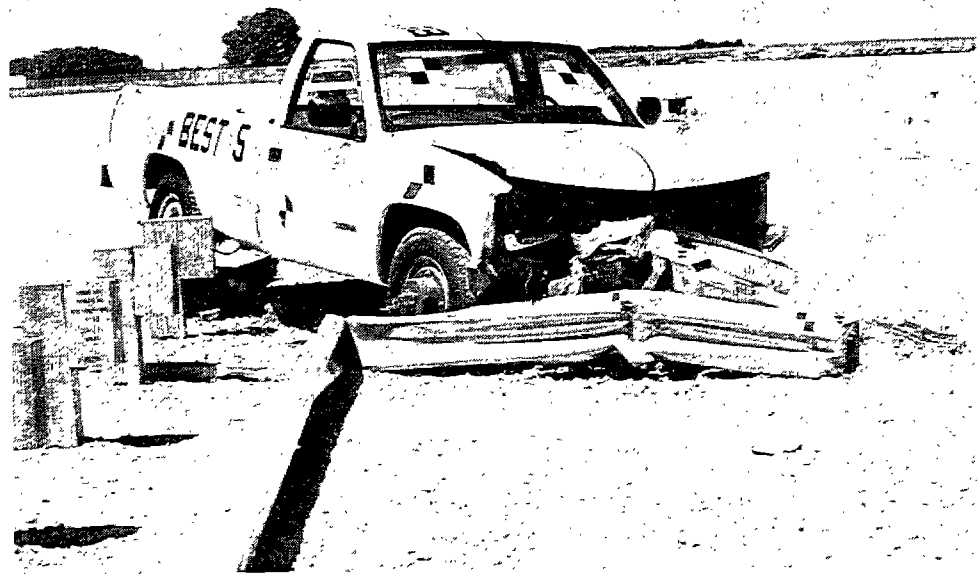
Figure 28. Post-test Photographs of Test BEST-5.

risk criteria were still satisfied. The normalized longitudinal OIV and ridedown accelerations were determined to be 7.6 m/s (25.0 fps) and 10.7 Gs, respectively. There was no measurable occupant compartment deformation. Although this test did meet all of the safety criteria required by NCHRP Report 350 (3), it was decided to redesign the impact head to prevent this jamming phenomenon.

This redesigned head, shown in Figures 6 and 7, redirects the cut W-beam further away from the impacting vehicle, reducing the chance of the W-beam interacting with the vehicle. Moving the outlet farther from the impact plate has the added advantage of accommodating deformation of the impact plate that sometimes occurs during severe accidents without compromising the outlet geometry.

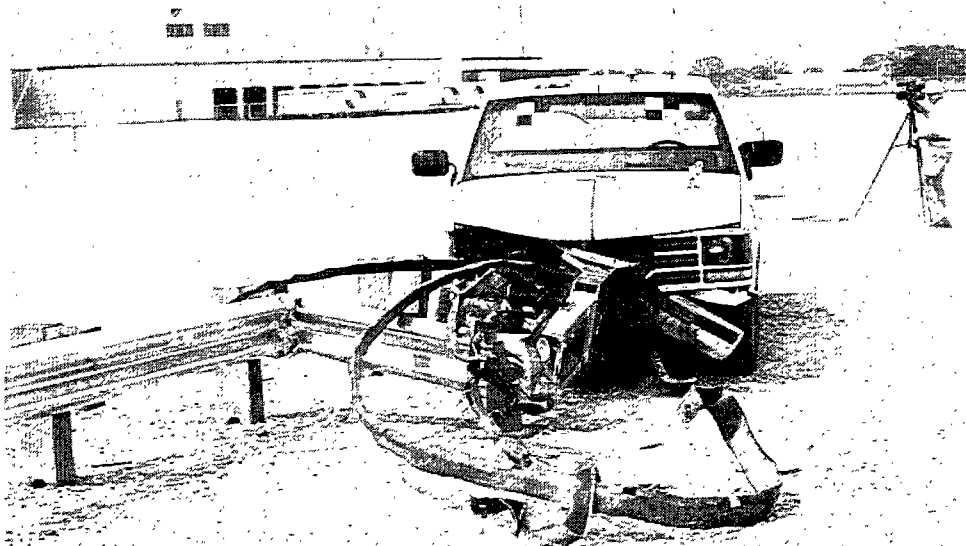
Figure 29. Post-test Photographs of Test BEST-6.

The BEST system with the redesigned head was impacted with a 1990 Chevy $\frac{3}{4}$ ton pickup at 101.3 km/h (62.9 mph) and 0.2 degrees toward the back of the rail. The system performed very well, as shown in Figure 29. The pickup was brought to a controlled stop after cutting through 7.44 m (24 ft - 5 in.) of W-beam guardrail. All of the posts broke off cleanly, and the head cut evenly throughout the test. The damage to the test vehicle was minimal, considering the severity of the impact, with a maximum front end crush of 35.6 cm (14 in.). There was no measurable occupant compartment deformation. Although the bumper wrapped around the front of the head in a manner similar to that observed in BEST 4, the revised outlet geometry prevented the outlet from being obstructed in anyway.

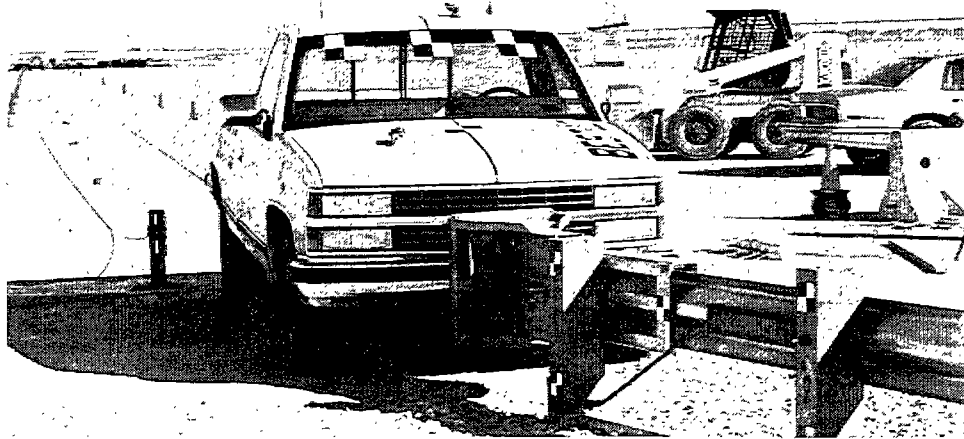
Figure 43. Impact Location, Test BEST-10.

NCHRP Report 350 (3) test 3-33 was conducted with a 1990 Chevy $\frac{3}{4}$ ton pickup impacting the system head-on at 102.1 km/hr (63.4 mph) and 14.3 degrees toward the traffic side of the system. The impact configuration for this test is shown in Figure 43. A summary of the test results is shown in Figure 44 and additional sequential photos are shown in Figure 45.

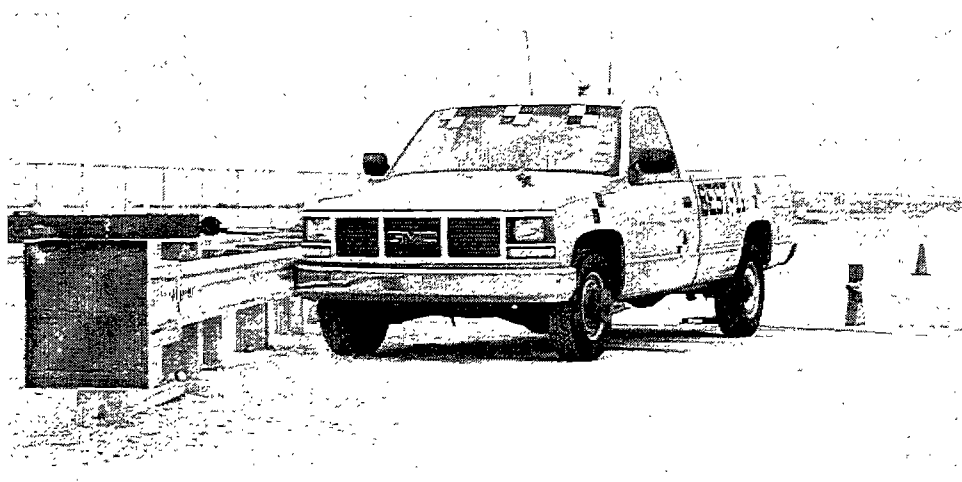
Figure 49. Impact Location, Test BEST-11.

This test was conducted to satisfy the requirements of NCHRP Report 350 (3) test 3-39 which requires that the terminal be impacted from the reverse direction at the midpoint of the terminal length with a $\frac{3}{4}$ ton pickup impacting at 20 degrees and 100 km/hr (62.1 mph). The test vehicle impacted the guardrail at the midpoint between post nos. 3 and 4 at 101.6 km/hr (63.1 mph) and 20.5 degrees. The impact configuration for this test is shown in Figure 49. A summary of the test results is shown in Figure 50 and additional sequential photos are shown in Figure 51.
